Eulah Matthews and William Neidinger

The Acropolis of Bylazora

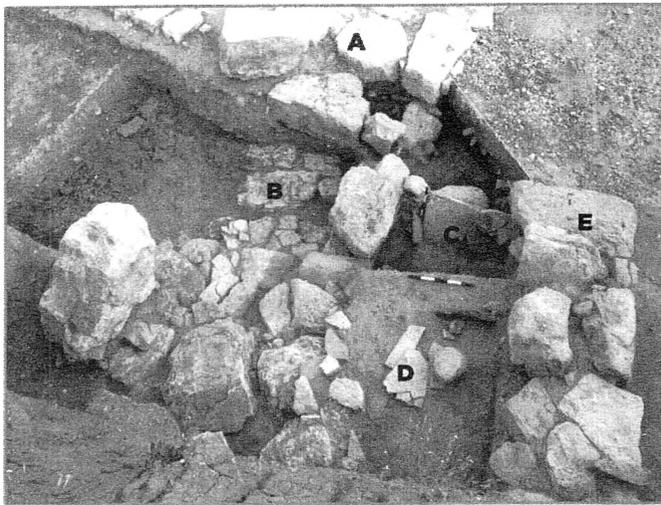
Several small buildings (Fig. 9) were built to the east of the propylon and

further uphill on the acropolis; they were definitively aligned with the propylon and cascaded downhill in terraces following the inclination of the ramp of the propylon, which was also probably the natural slope of the hill. A deep sounding through the floor of one of these buildings revealed an earlier structure of Phase 1 that followed a similar alignment (Fig. 13), meaning that the general orientation of the northern entrance to the

The propylon (**Fig. 9 and 11**) consisted of two towers flanking the entrance, an inclined ramp, and a rectangular room whose stones were laid flat; the ramp and rectangular room were separated by a raised threshold, whose stones sport a socket for a locking bolt and show signs of vehicular wear. Two thick walls (L12.10 and M14.7) served as the lateral walls of the propylon and supported the roof. Evidence for a tiled roof came from the abundance of roof tiles found directly above the paving stones of the ramp in the 2008 season. Most of the eastern lateral wall was quarried away in antiquity. In the 2010 season we discovered some of the foundation courses of the eastern wall of the rectangular room (**Fig. 12**).

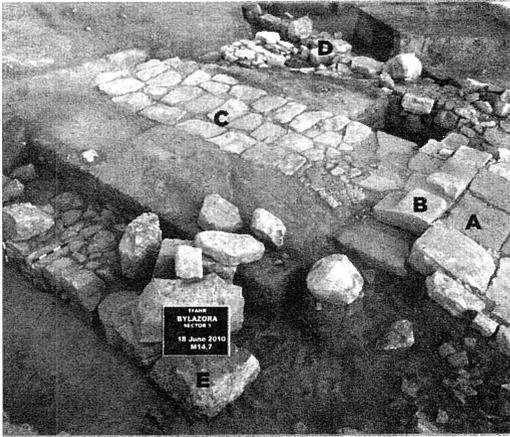
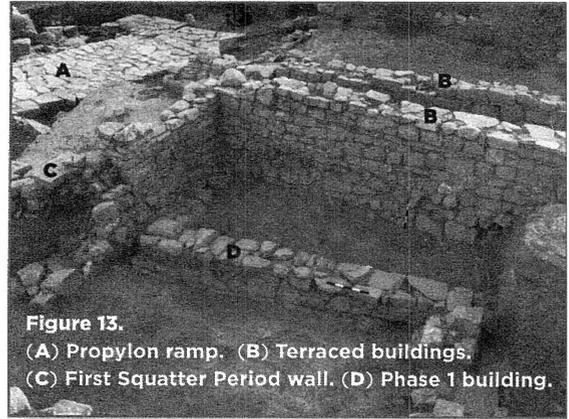
Figure 13.

(A) Propylon ramp. (B) Terraced buildings. (C) First Squatter Period wall. (D) Phase 1 building.
