Elizabeth R. Gebhard

Discovery of the First Theater at Stobi

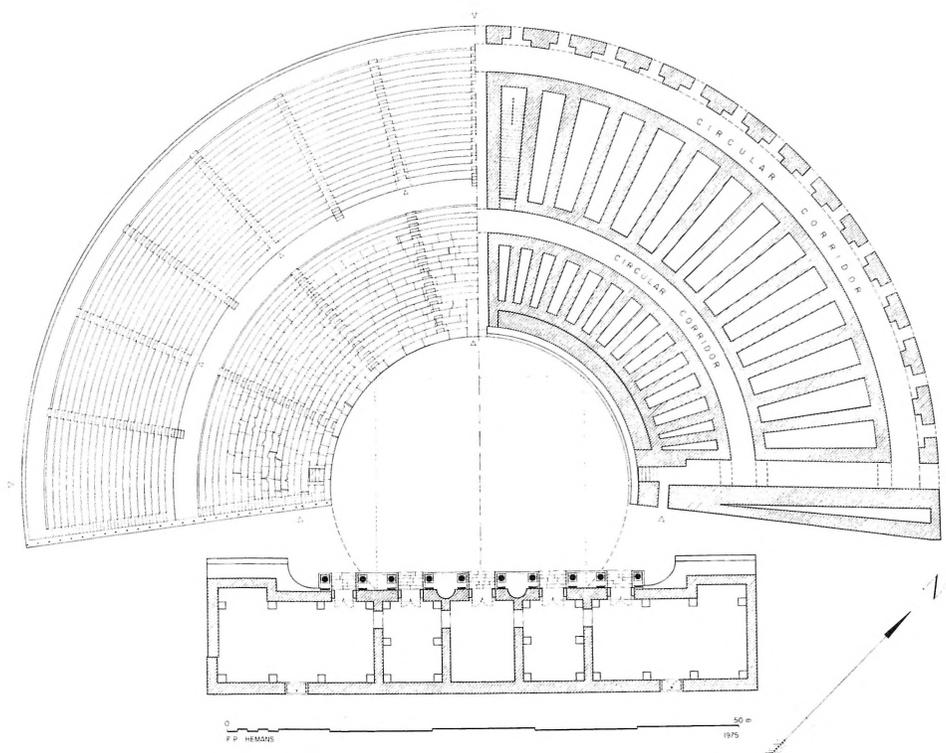
Fig. 1: Restored plan of the Marble Theater (F. Hemans, 1981)

The marble theater that had been exposed consisted of a simple, rectangular scene-building ornamented by a two storied *scaenae-frons*. Six porches supported the colonnade and five stairways led directly to the orchestra; there was no stage (Figs. 1, 2).² At either end of the colonnade curved bays joined shallow paraskenia to the façade. The high walls of the paraskenia are conspicuous today, and they played an important part in our discovery of the first theater. The *parodoi*, bordered by marble analemata (retaining walls) along the auditorium, were open to the sky and lay at an oblique angle to the scene-building. A high podium surrounded a large orchestra with an arc of 194 degrees and a diameter of 29.40 m. Figure 2 shows the orchestra in 1974.³ Small doorways at the lower ends of the *parodoi* gave access to radial corridors running inside the retaining walls. At the lower ends, the corridors finished in a short flight of steps that led to the top of the podium and the first rows of seats.

It had always been thought that the curved wall that extended from the final block of the green sandstone course to the end of the marble *scaenae-frons* was simply part of the design of the marble theater (Fig. 1). Conspicuous change in the masonry, however, can be detected between the curved wall and the high foundation (Figs. 14-16). When we looked at the foundation level exposed in trenches XVI on the east side and XXXII on the west.¹³ It became evident that the screen wall replaced the corner of the high foundation where it had turned to the south. It had obviously been added to cover the rough faces of the blocks and masonry where the return had been chiseled off (Figs. 1, 12, 14). The curved screen wall rested on the exposed section of the foundation where the upper part had been removed. It was not bonded (Fig. 15, east end). The curved walls were thus added in Phase II, to cover the junction between the sandstone return and the final porches of the marble façade.

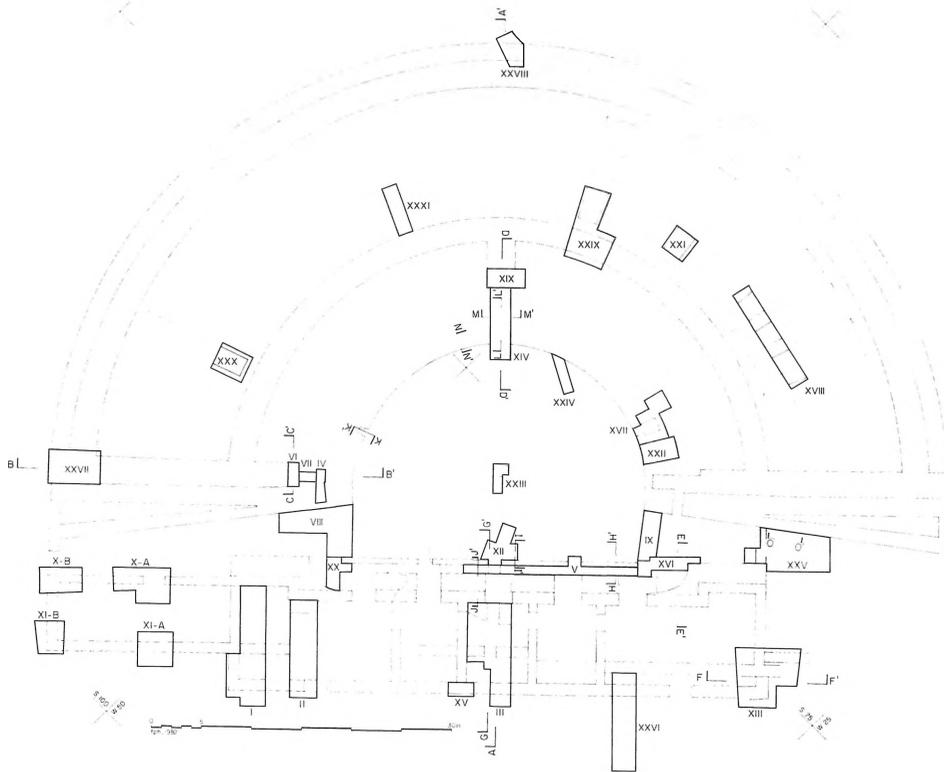
Fig. 3: Trench Plan (F. Hemans)

The west *parodos* and the west *paraskenion*, the east end of the east *parodos* and scene-building, and the eastern side of the cavea below the seat foundations remained unexcavated at the close of our project (Fig. 3). Rather than clearing the remainder of the building, our objective had been to document the stratigraphy in the scene-

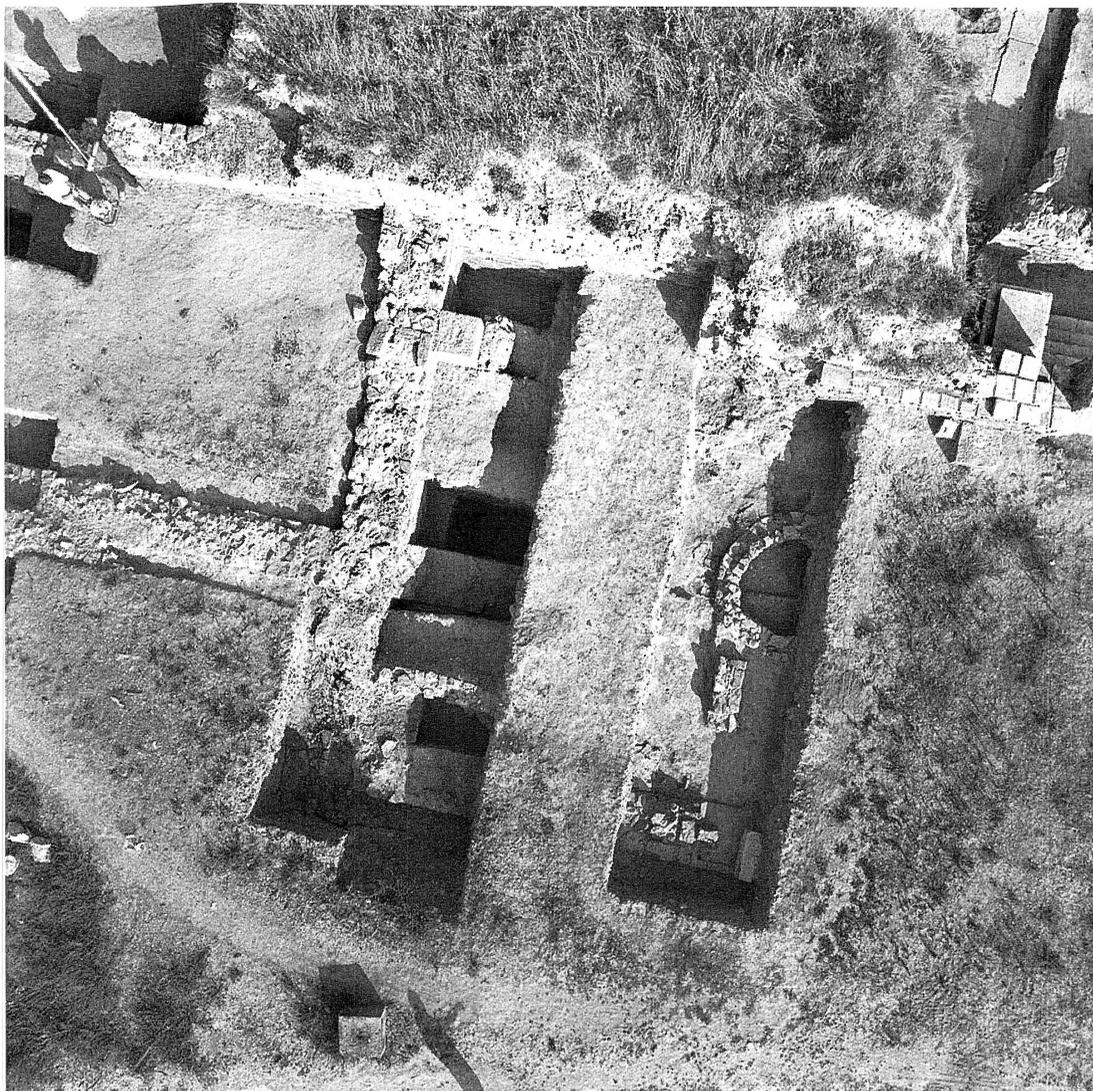
Fig. 4: Aerial view of Trenches I and II, looking north (1974) (74-169-16)

Discovery of the first theater at Stobi occurred unexpectedly in the summer of 1973 when trench I was opened to explore the west end of the scene-building. In Figure 4, taken in 1974 looking north, trench I lies to the left and trench II to the right. The west paraskenion, unexcavated, appears at the top.

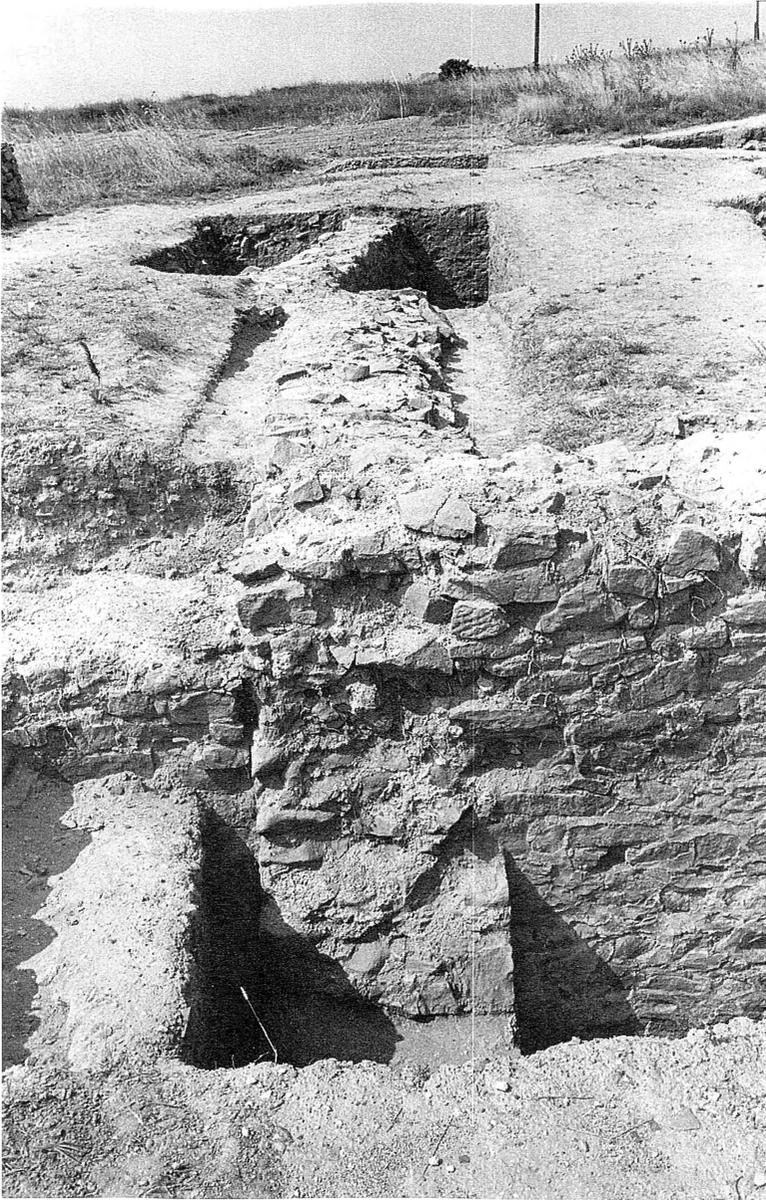
Fig. 5: View of the corner between walls 1 and 2, looking west (1974) (74-152-6)

The first suggestion of an earlier building came from the inner face of the west wall of the scene-building where a rough, jagged surface interrupts the facing of the wall (Fig. 5).⁴ A second indication of change is a division in the masonry where a southern

extension was added to the wall some time after the initial construction. Further excavation in trench I revealed that the west wall had originally formed a corner with a hitherto unknown wall running eastward, which is visible in the foreground of Figure 5. The two walls evidently formed the southwest corner of a large building. Later, the eastbound wall, labeled wall 1 in Figure 6, was demolished and the west wall, wall 2, remained standing and was extended to the south to join a new east-west wall, which is the rear wall of the marble scene-building (Figs. 1, 6). A hard-packed floor associated with walls 1 and 2 lay at a depth of 2 m. (elevation 137.50 m.) below the floor of the second building.⁵

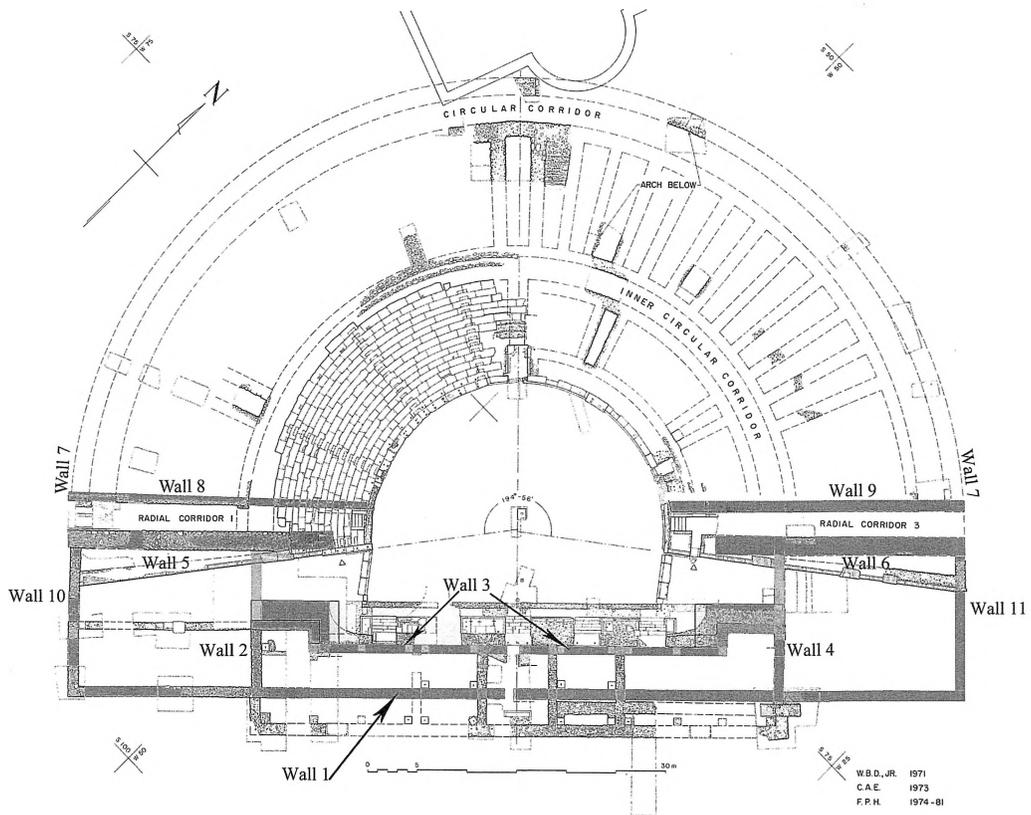
Fig. 6: Actual state plan with walls of the first theater numbered and outlined in dark grey. (10/2010; Peggy Sanders PDF)

exerted on the second. The two theaters appear together in Figure 6 where the early walls are superimposed on the actual state plan and numbered 1-11.

wall 1. Wall 2 was bonded to the west end of wall 1, as described above. At the north end it joined the high foundation that supported wall 3, the front wall of the first and second scene-buildings (Fig. 6). On the north face of the high foundation a narrow strip of rough surface can be seen from the bottom to the top of the masonry, that shows where Wall 2 had been bonded to the foundation and later removed (Fig. 7). In the first theater, the wall had continued to the north and crossed the area occupied by the later parodos. On the east side of the building a similar rough surface can be seen on the east end of the high foundation where wall 4 had been removed (Fig. 8). In the east parodos trench XXV uncovered the lower section of wall 4. At ground level wall 4 is bonded to the high foundation of wall 3, as seen in the foreground of Figure 8. The north end of wall 4 continues under the marble analemma, which shows that, before construction of the marble analemma, it had joined an earlier wall lying farther north, wall 6, discussed below (Fig. 6).

foundation level wall 2 was bonded with the well-preserved standing masonry that served as the west paraskenion of the marble theater. Thus, along with wall 2, it too had belonged to the first building. A similar construction stands at the east end of the scene-building. These high blocks of masonry are the largest portions of the early structure to survive above ground. At the rear (south) of the foundations stands a wall that served as the front of the scene-building in both the first and second phases, and it is labeled wall 3 in Figure 6.

theaters of Scupi and Salonae.⁹ The well-preserved example at Augusta Emerita (Merida) in Lusitania, Spain provided a model to guide our reconstruction in Figure 20.¹⁰ That type of *scaenae-frons* included a colonnade raised on porches along the front wall. Steps led from the doorways to a stage which was an essential element in Roman theater design. We had wondered at its absence in the marble theater. The first theater, if it followed the conventional pattern, must have had a stage. Thus, the entire façade would have been supported on a high foundation, which raised the porches and stairs to the level of the stage. When the plan was changed, the foundation was removed, leaving only its lowest portion as the concrete platform seen today. It was this major change in elevation as well as a new plan that required demolition of the first scene-building. At the ends of the building, however, the high foundation that supported the front wall was retained in the new building (Fig. 6).

Let us return to walls 4 and 2 where they crossed the later parodoi (Fig. 6). At the north end of trench XXV in the east parodos, wall 4 continues beneath the marble analemma

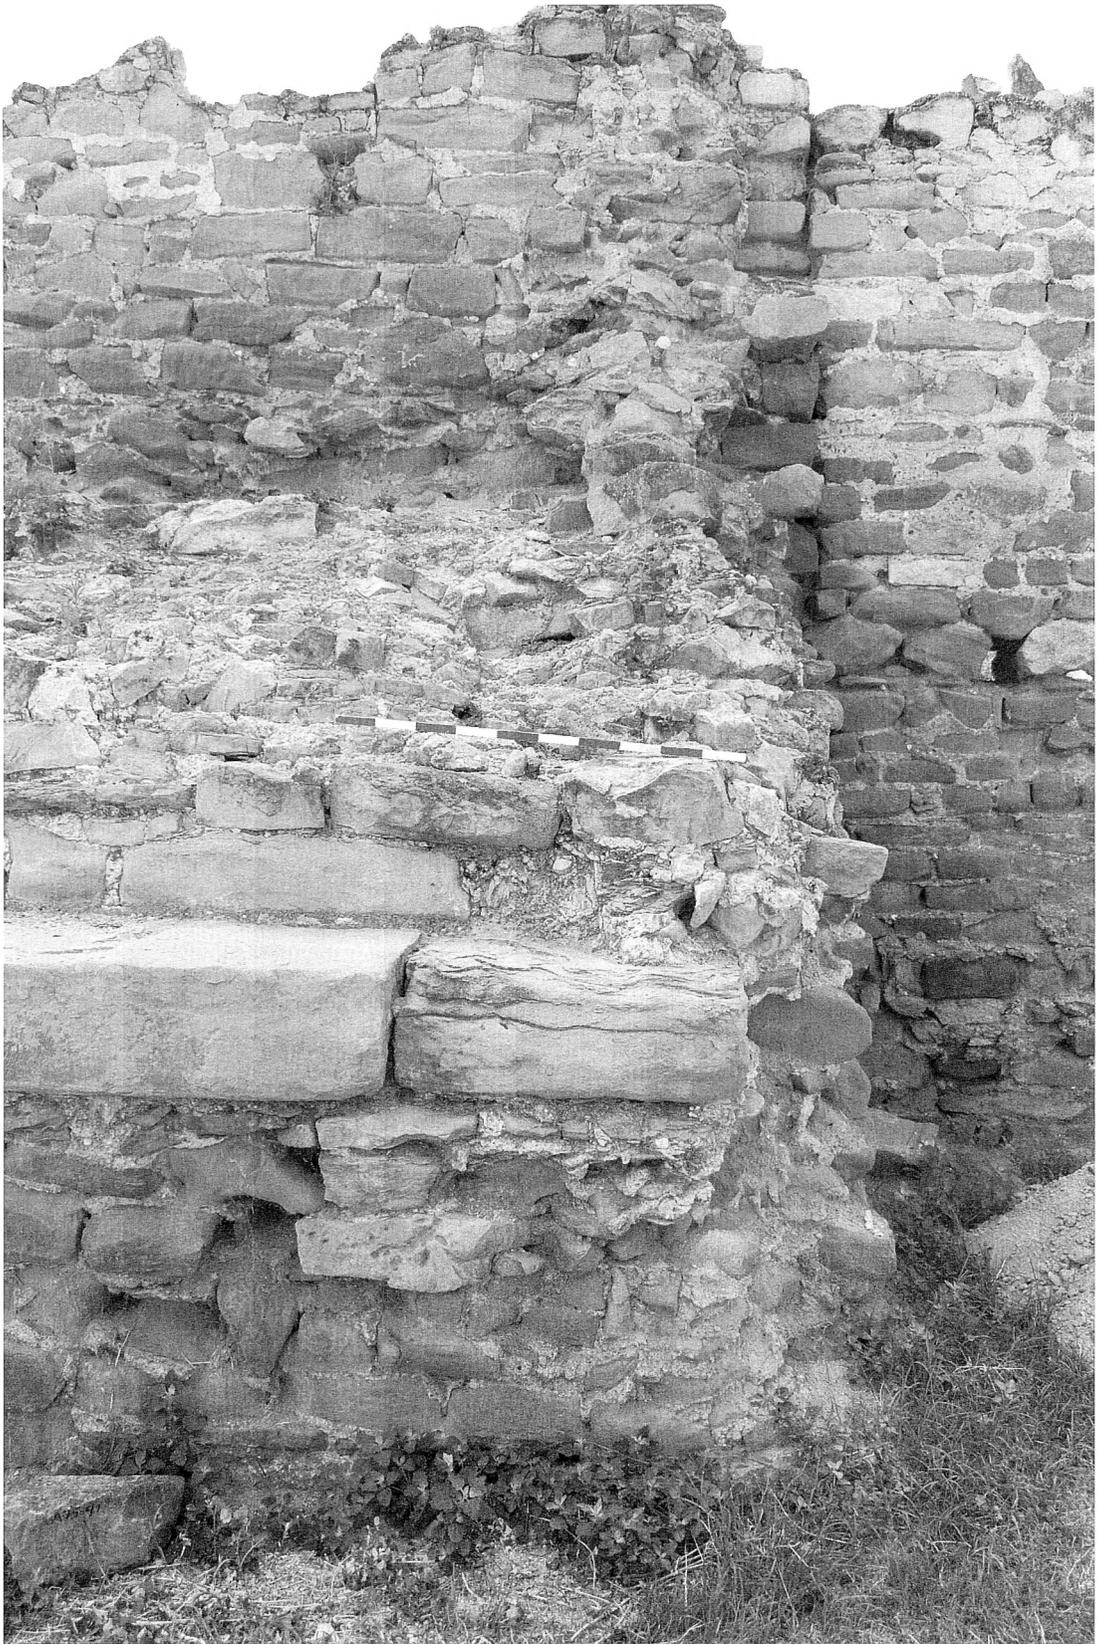
Fig. 7: West end of west paraskenion, looking south with traces of bonding of wall 2 (2010) (DSC-0375)

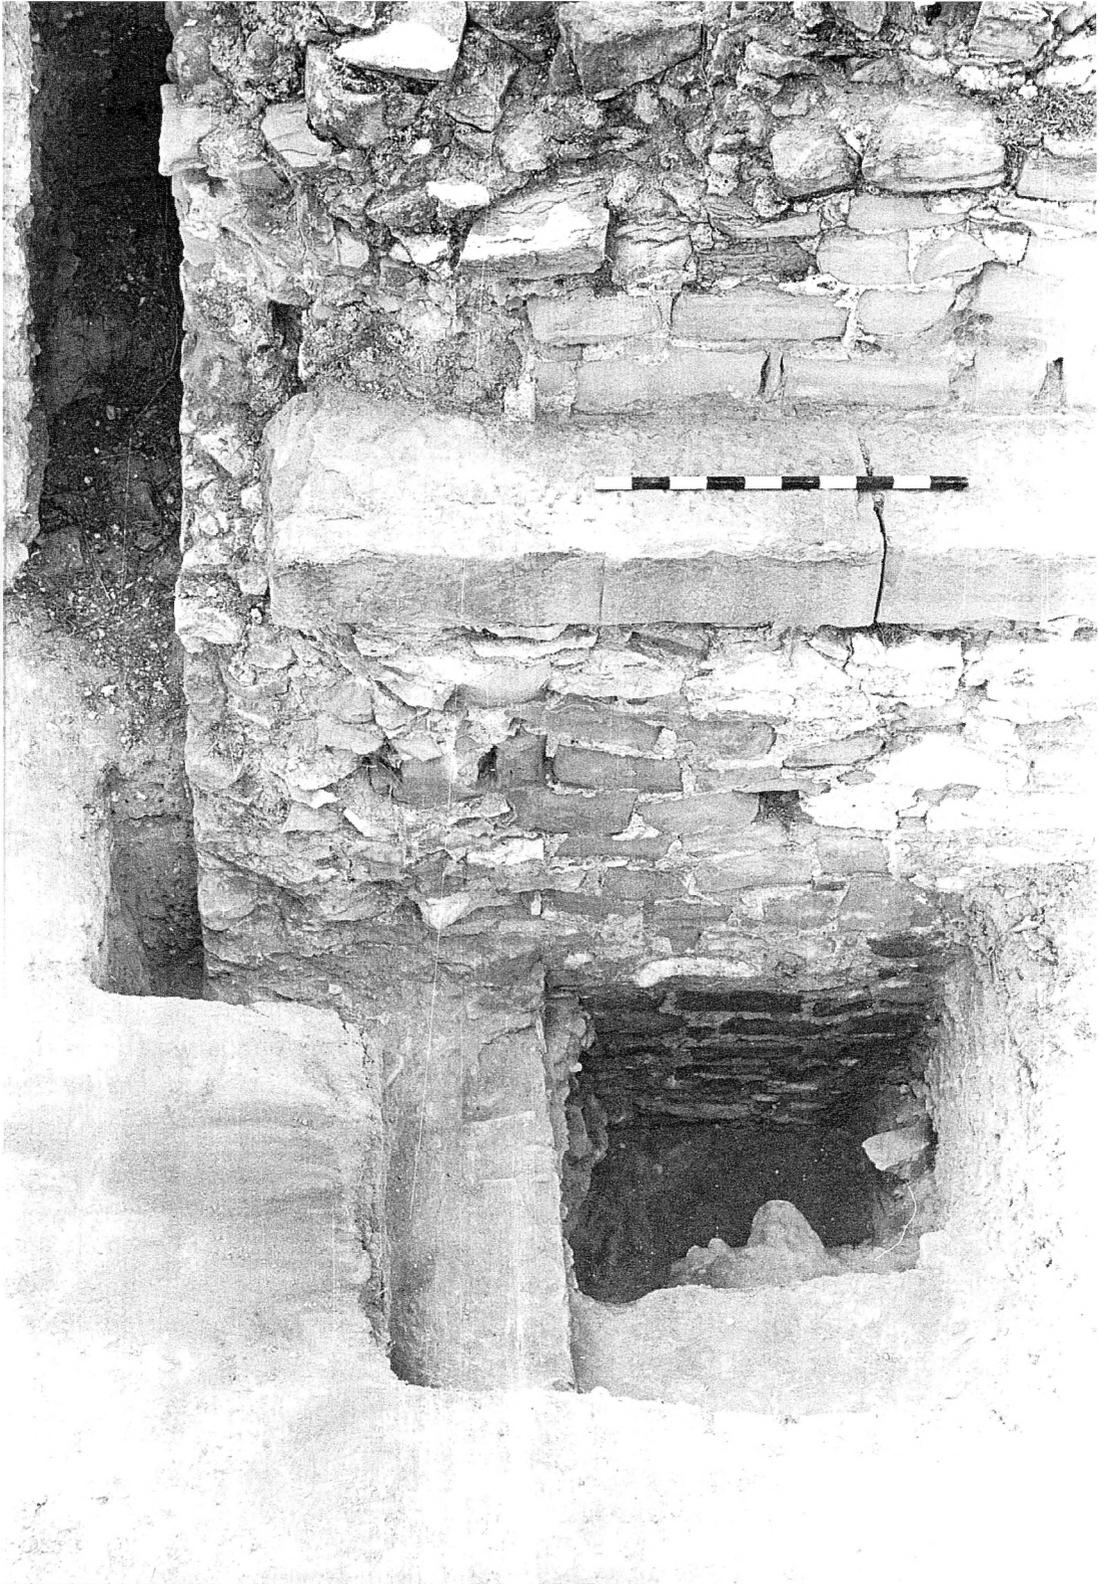
Fig. 8: East end of East Paraskenion (wall 3) and corner with wall 4, in Foreground (1981) (81-34a-6a)

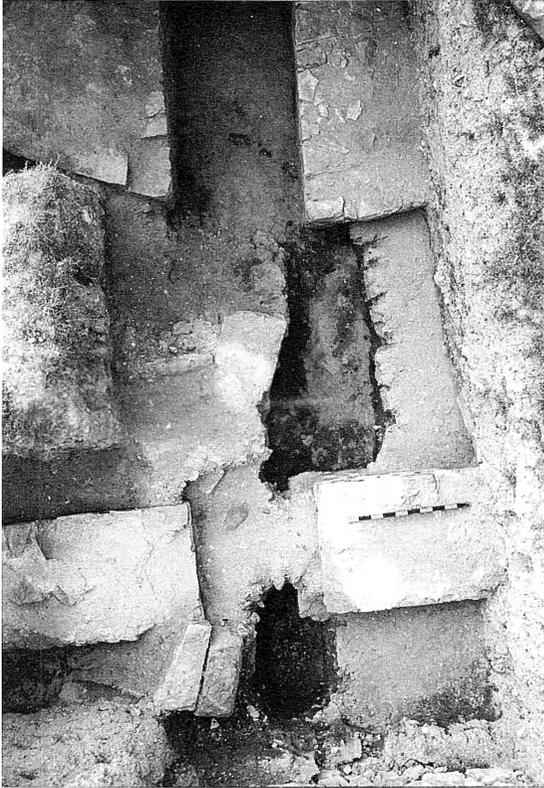
Fig. 9: Trench III from above, looking north
75-90-43

in section in Figure 10, taken through trench III in the center of the scene-building. Figure 9 gives a view of the same trench from above, looking north. The only unusual feature of the platform in the excavated section is a deviation in the line of the rear face at both sides a passage reserved in the center (Fig. 9). The foundation on the west side runs from the corner of the passage at an angle toward the northwest. On the east side of the passage, the rear face lies at an angle toward the northeast although the slope is less pronounced. Since the rear of the foundation was likely to have followed the shape of the masonry that had originally stood above it, the deviations at either side of the central passage gave us a clue to the type of façade that had been used in the first theater. The front wall apparently did not follow a straight line in the center, as its successor in the marble theater. It curved outwards towards the rear, forming a niche that framed the central doorway of the façade.

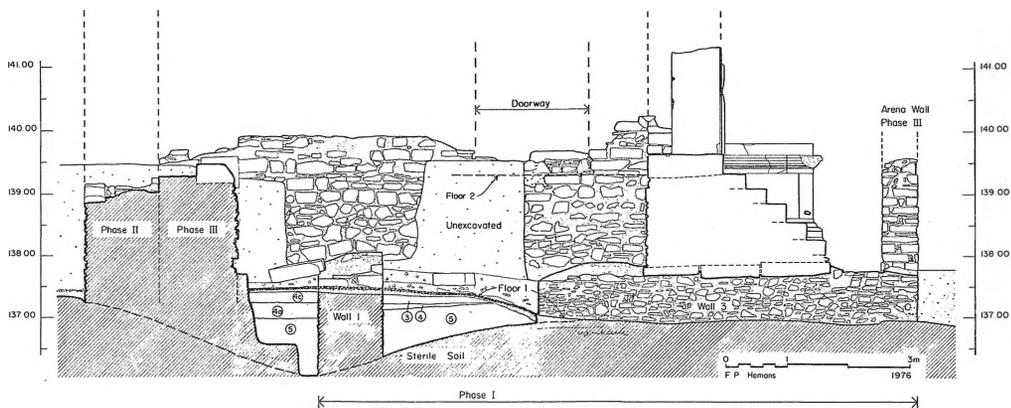
Fig. 10: Trench III, Section G-G, looking west.

Before we consider wall 3 and the high foundations at either end, let us examine the concrete platform that lay between them. The carefully constructed foundation extends for 53.50 m. The fact that it is bonded with the foundation of wall 3 shows that it was part of the same construction, but the mass of masonry that it had supported, comparable in height to the foundations of wall 3, was later removed. The remaining portion rising slightly above ground level has been exposed in trenches in the center of the scene-building and along the front face.⁸ For the most part the foundation has a virtually level surface, as it appears

At completion of trench III the ground floor of the first scene-building was revealed. A doorway in the rear wall (wall 1) gave access to the building. The inside floor was composed of compacted soil, and a ramp led into a passage through the foundation to the orchestra.¹⁵ The section in Figure 10 shows the second phase of the building. In the early theater, however, the first floor of the scene-building would have been at least 2 m. above ground level, and a basement room would have lain below. What now appears as a low channel through the concrete foundation can be restored in the first phase as a corridor, ca. 1.10 m. wide and perhaps 2 m. high.

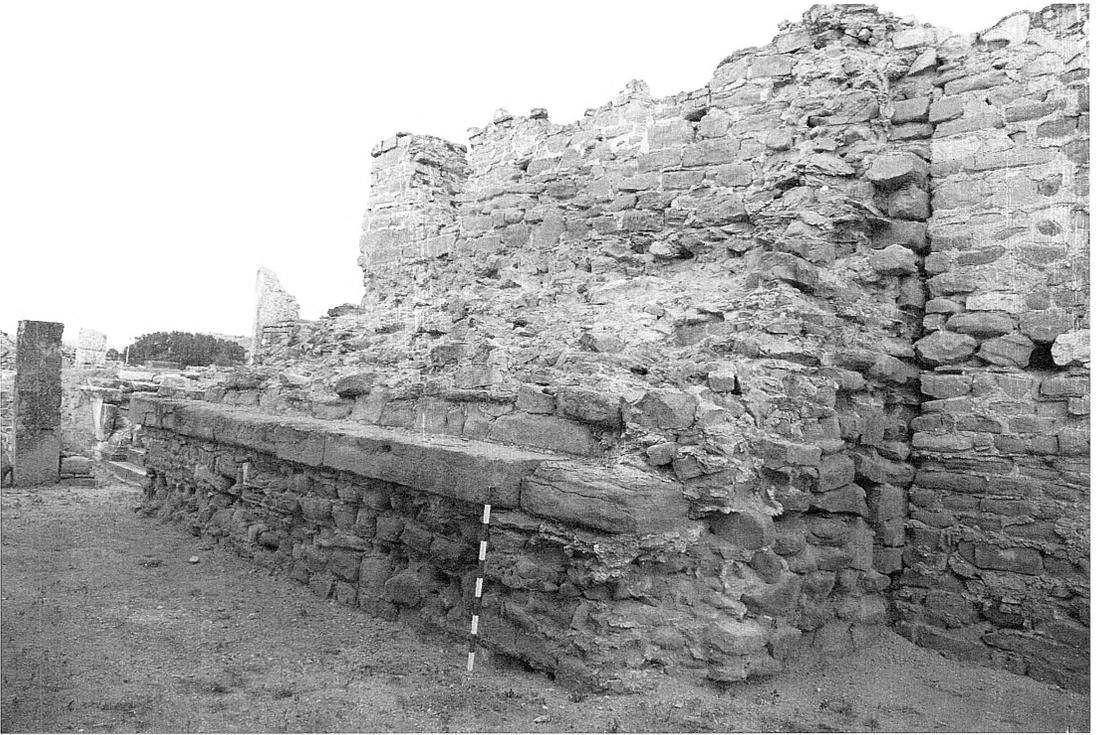
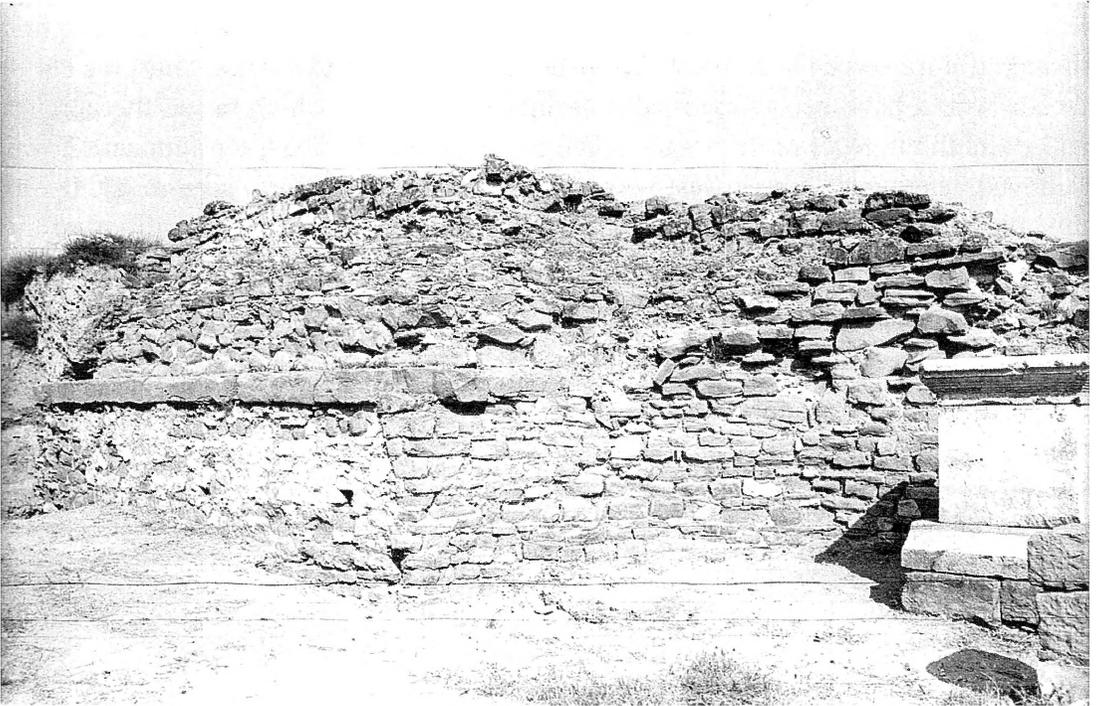
We turned therefore to the high foundation that remained at either end of the building for clues to the first façade. Each block of masonry was about 12 m. high by 4.40 m. wide with an almost identical stepped profile (Figs. 11 west; 12 east; 13, section). Along the south side of the foundation stands the front wall, reused in the second scene-building.¹¹ Below the wall, the concrete projects ca. 1.50-1.55 m. and then drops down for ca. 1.26-1.30 m. to a ledge of green sandstone blocks.¹² The orchestra lay about 2 m. below the sandstone course.

Fig. 11: West Paraskenion, looking southeast (2009) DSC 115

Fig. 12: East Paraskenion, looking southeast (1978) 78-98-13a

The curious stepped profile of the high foundations with the prominent course of large sandstone blocks called for an explanation (Figs. 12, 14). As discussed above, the type of *scaenae-frons* would have been one that alternated curved and probably rectangular niches between porches. The porches would have stood at the same height as the stage. The sandstone course lying ca. 2 m. above the orchestra at either end attracted our attention since a similar course of green sandstone lay at the foot of the porches in the marble theater (seen in profile in Fig. 10, at the base of the eastern end porch in Figs. 12, 14). It seemed possible that the same taste for polychromy influenced the design of the first theater. If so, the masonry “step” above the sandstone course will have formed the core of a long porch at either end of the façade (Figs. 11, 12). Slabs of marble standing on the sandstone blocks would have revetted the outside, and above there would have been a crown course and stylobate for the columns, as shown on the restored drawings (Figs. 19, 20).¹⁴ The precise dimensions of the niches, doors and steps in the center must remain conjectural, but the façade will have been of this style.

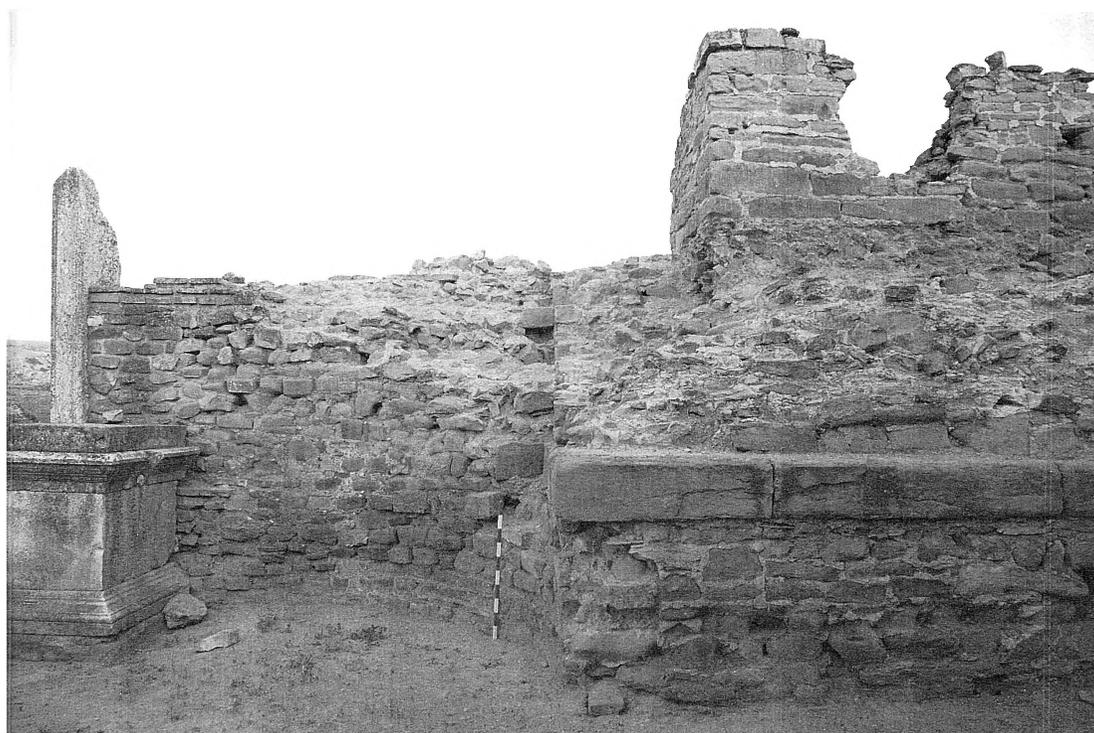
On the west side recent excavations have added to our understanding of the junction between the two phases of the scene-building. A well-preserved section of wall 3 at the corner of the east-west portion and its return to the south appears in Figure 16. The east face of the return is seen at the back of Figure 17, and in front of it is a remnant of the same wall where it had resumed its east-west course. In the foreground is the front wall of the second theater in which bricks were used. It was built slightly farther to the north, toward the orchestra. A patch at left belongs to the second period. Figure

Fig. 16: West Paraskenion, separation between Wall 3 and Second Scene-building (2009) DSC 86

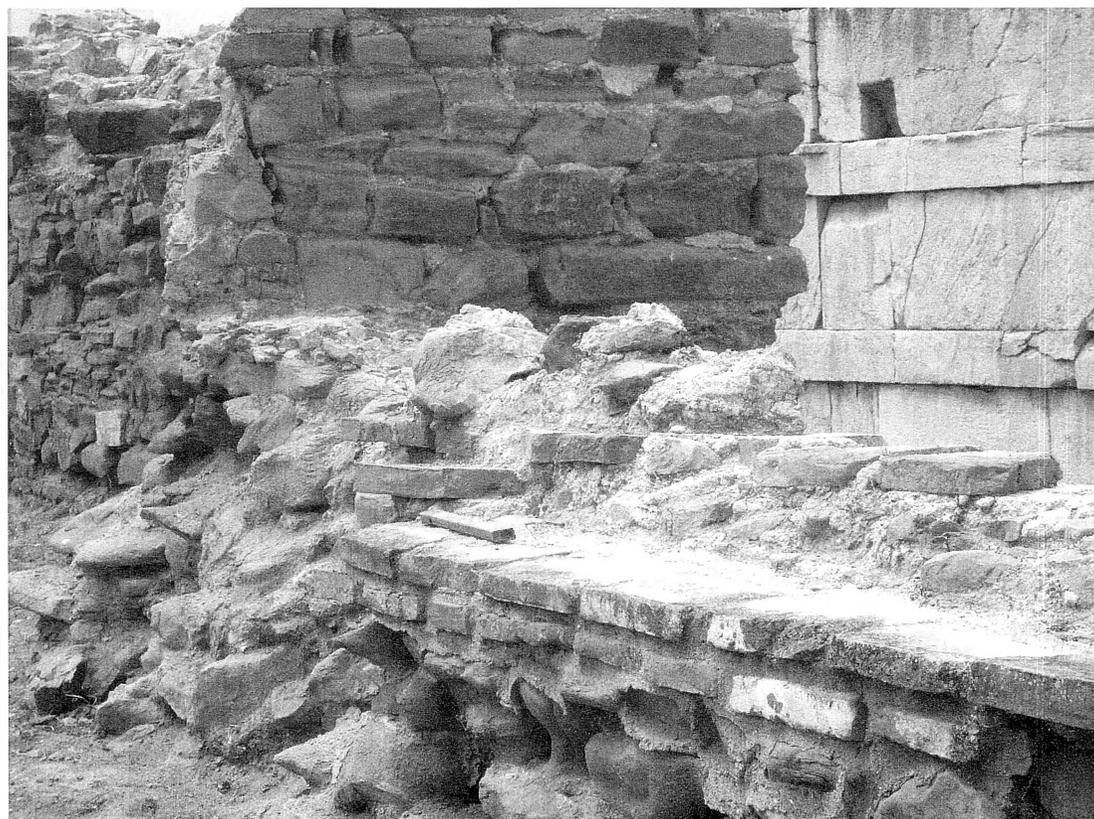
Fig. 17: South face of West Paraskenion, wall 3 at left; front wall of second scene-building at right. (2009) P309

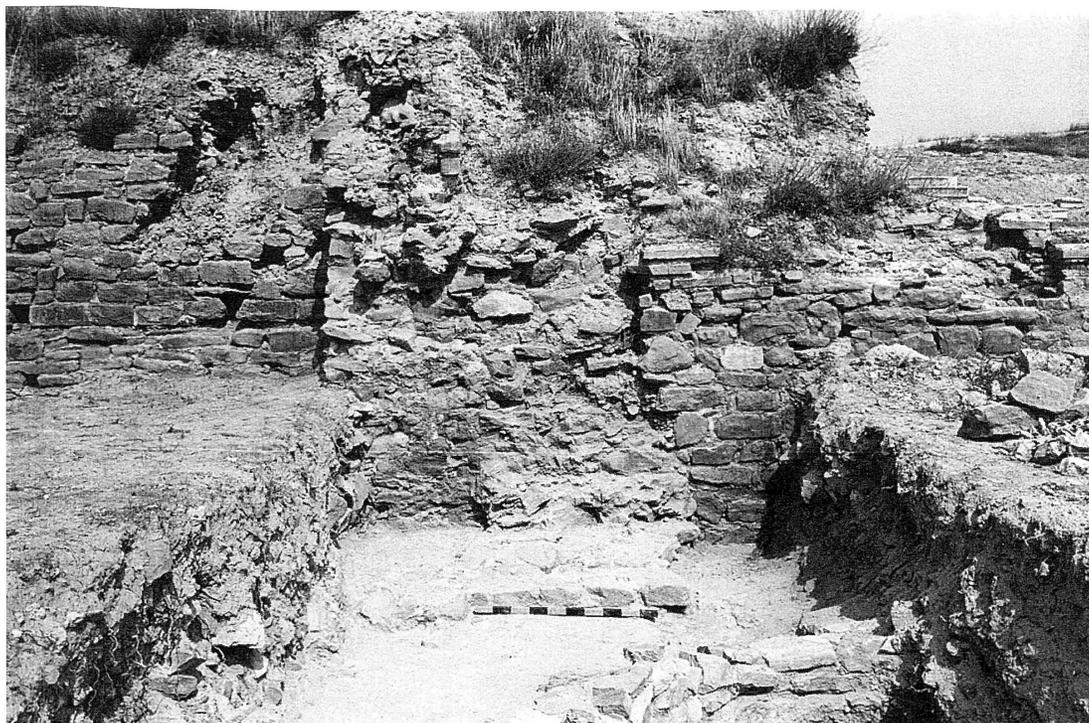
18, shows the south side of the same area before trench II was backfilled in 1974. The second wall stands to the right with its face well preserved. In the center are remains of the first wall at the corner between the north-south return and the main east-west section. Further excavation might enlarge the picture but the general outline of the changes between the first and second phases of the façade is clear. In summary: the portions of wall 3 preserved today at either end of the building had originally stood along the rear face of the two end porches, as restored in Figure 20. At the inner corners of the porches the wall had returned south toward the front of the building and then turned east-west along the façade (Fig. 6). When the plan was changed, most of the front wall was demolished; the returns of the end porches which had run along the sides of the final niche at either end were cut back since they could not be used in the new design. Screen walls were added to cover the rough masonry and curved inward to make a transition between the northern face of the former porches and the final porches of the new façade. The moving of the second front wall slightly to the north of wall 3 left the small remnant of the first wall that is seen in Figures 17 and 18, one further block may be added here. A massive slab of white marble recovered from the fill in trench III in the center of the scene-building belongs stratigraphically to phase I, and its size suggests that it was not moved far from its original location. The block, veined in grey, measures 3.05-3.076 m. by 1.60-1.68 m. by 0.44-0.455 m. Figure 21 shows it being lifted. It is larger than any block preserved in the marble theater and thus may have been discarded as unsuitable, yet re-cutting would have been an obvious solution. If it belonged to the first scene-building, the threshold of the center door is a possibility. There are no cuttings or other identifying marks. No other blocks can certainly be assigned to the first scene-building.

Fig. 18: Foundation of Wall 3 uncovered in Trench II (1974)
74-152-44

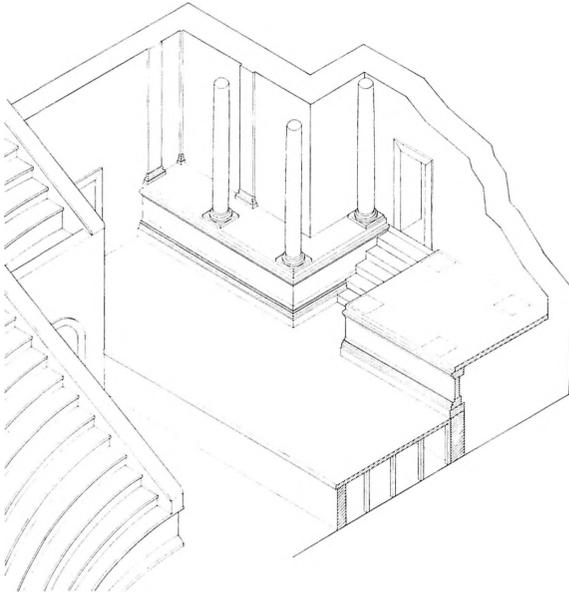
Fig. 20: Restored view of first scaenae-frons (F. Hemans)

The green sandstone course that we have suggested lay at the base of the porches would have been at the level of the stage. If so, the stage would have been about 2.10 m. high above the orchestra, as restored in Figure 20. There will have been a stage wall crossing the orchestra, but it has not been excavated.

of the second theater. Although nothing more could be excavated, it seems likely that walls 2 and 4 belonged to rooms at the ends of the scene-building that Vitruvius calls *versurae* (V.6.3). Further evidence for such rooms is seen in the westward continuation of wall 1 where it formed the south wall of the west *versura* (Fig. 5). The rooms would have bordered the stage at either end, providing an additional door onto the stage and space for storage and other theatral needs, as restored in Figure 20. Further excavation is required before more can be said about them.

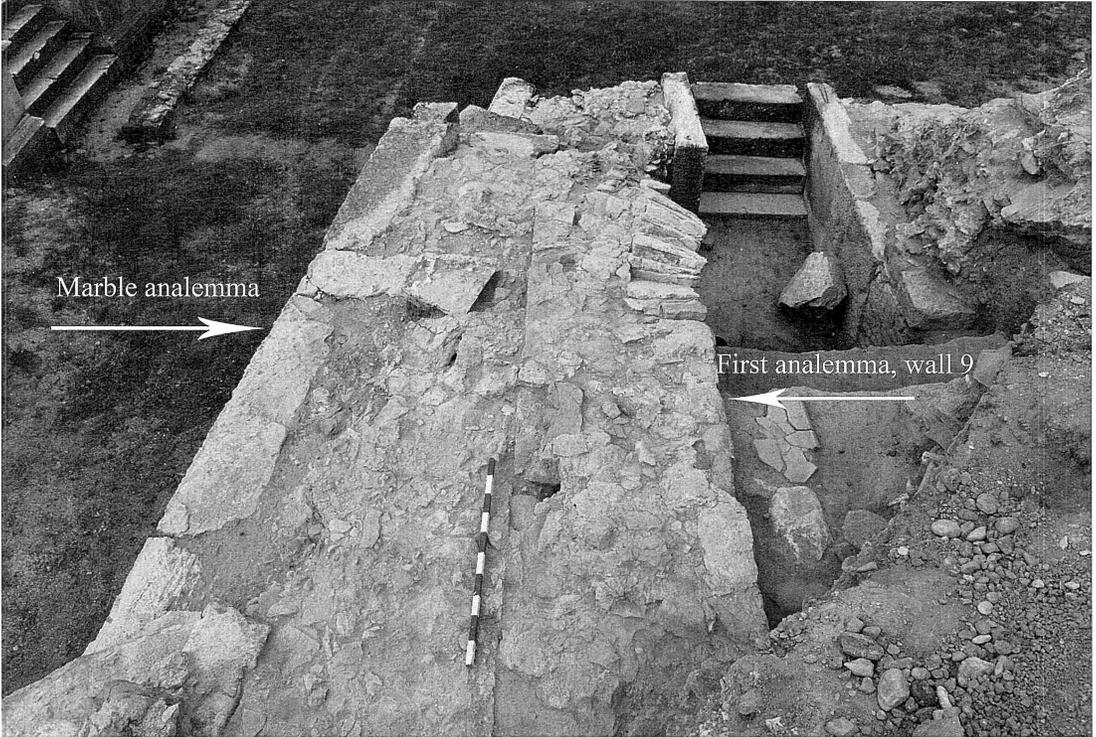
(Figs. 1, 6). The marble retaining walls of Phase II, lying at an angle to the scene-building, had evidently been added to an existing construction. The division is clear in a view on the east side where the upper seats are no longer preserved (Fig. 22). The marble analemma is seen at left and the first analemma (wall 6) at right. In the later theater the vaulted passages no longer gave access to the orchestra but to the first rows of seats via a short flight of stairs leading up to the orchestra podium, as pictured in Figure 22. Thus, walls 6 and 9 on the east side and 5 and 8 on the west in the first theater were retaining walls for the parodoi. Those passages became corridors in the marble theater (Fig. 6). Goce Pavlovski in recent excavations on the east side of the cavea uncovered the stairs and marble revetment that had been added to the existing masonry at the end of the east parodos when the parodos was converted to a corridor that gave access to the cavea.¹⁶ He also exposed the west end of the original vault of the parodos. The same construction is found at the west side of the theater, but the seats above are intact and the cement added for conservation covers the original remains.¹⁷

Fig. 22: Wall 9 and East analemma, looking west from above DSC 47

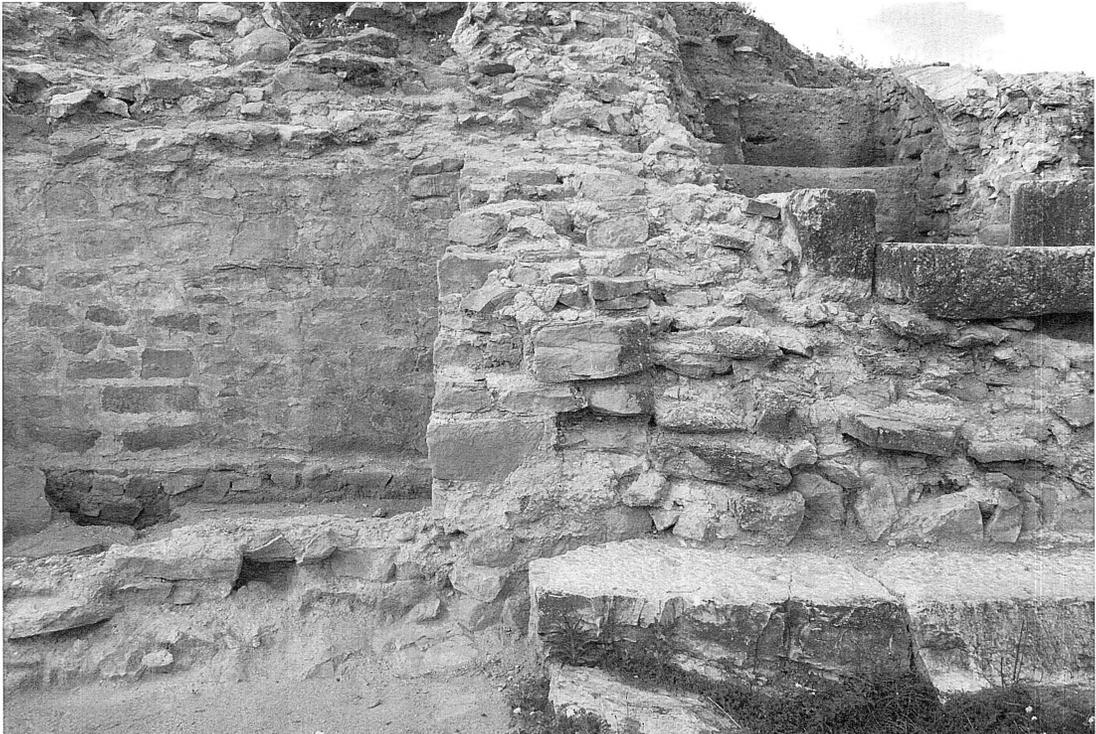
A further question concerns the extent to which the first cavea was completed. At the east side of the *ima cavea* excavations in 2009 and 2010 have cleared a portion of the lowest annular wall that is bonded with wall 9 (Fig. 23). Thus, it appears that at least the foundations of the *ima cavea* were completed as well as the radial walls for the parodoi, but it is not certain that seats were built above the substructure.¹⁸

Fig. 23: Wall 9, from below looking east
