Miško TUTKOVSKI

PAINTINGS IN THE OLD EPISCOPAL BASILICA IN STOBI ANALYSES OF THE TECHICAL-TECHNOLOGICAL CHARACTERISTICS

National Institution Stobi
mishko.tutko@gmail.com

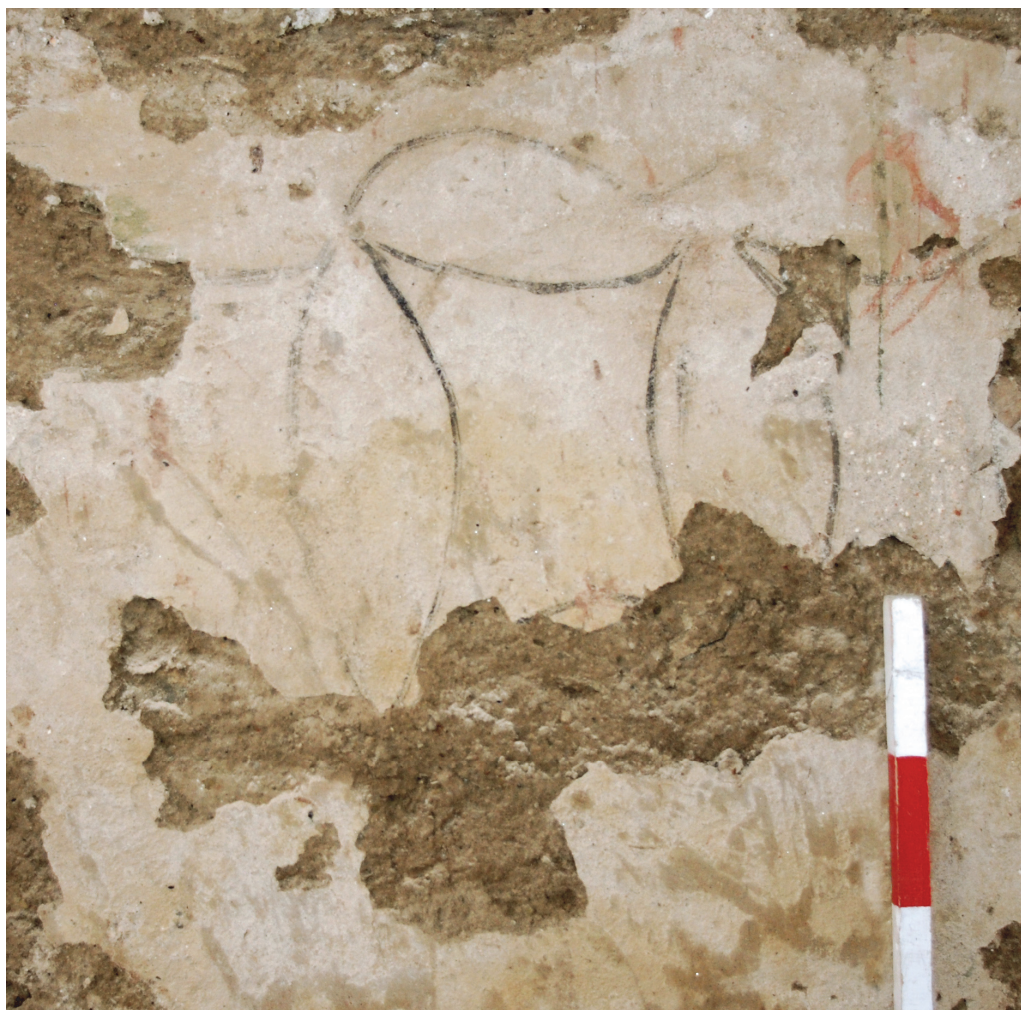
Fig. 4. South wall – substrate of the I painting phase. Sketch of three kantharoses (photography - M. Tutkovski)

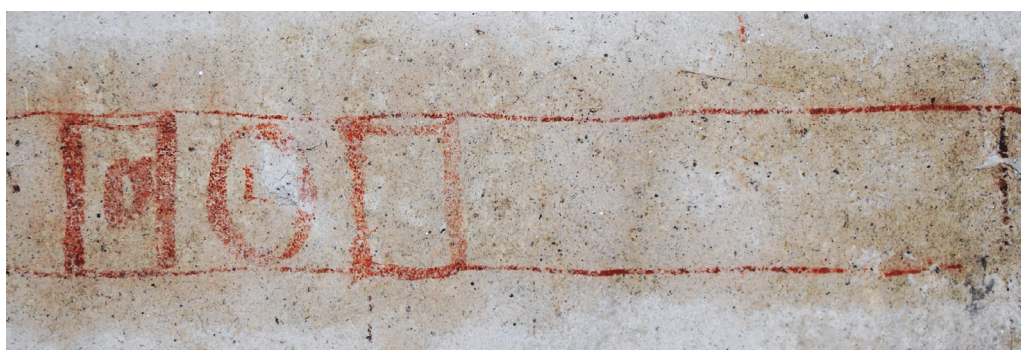
Fig. 5. South wall – substrate of the I painting phase. Several signs in rectangular frame. (photography - M. Tutkovski)

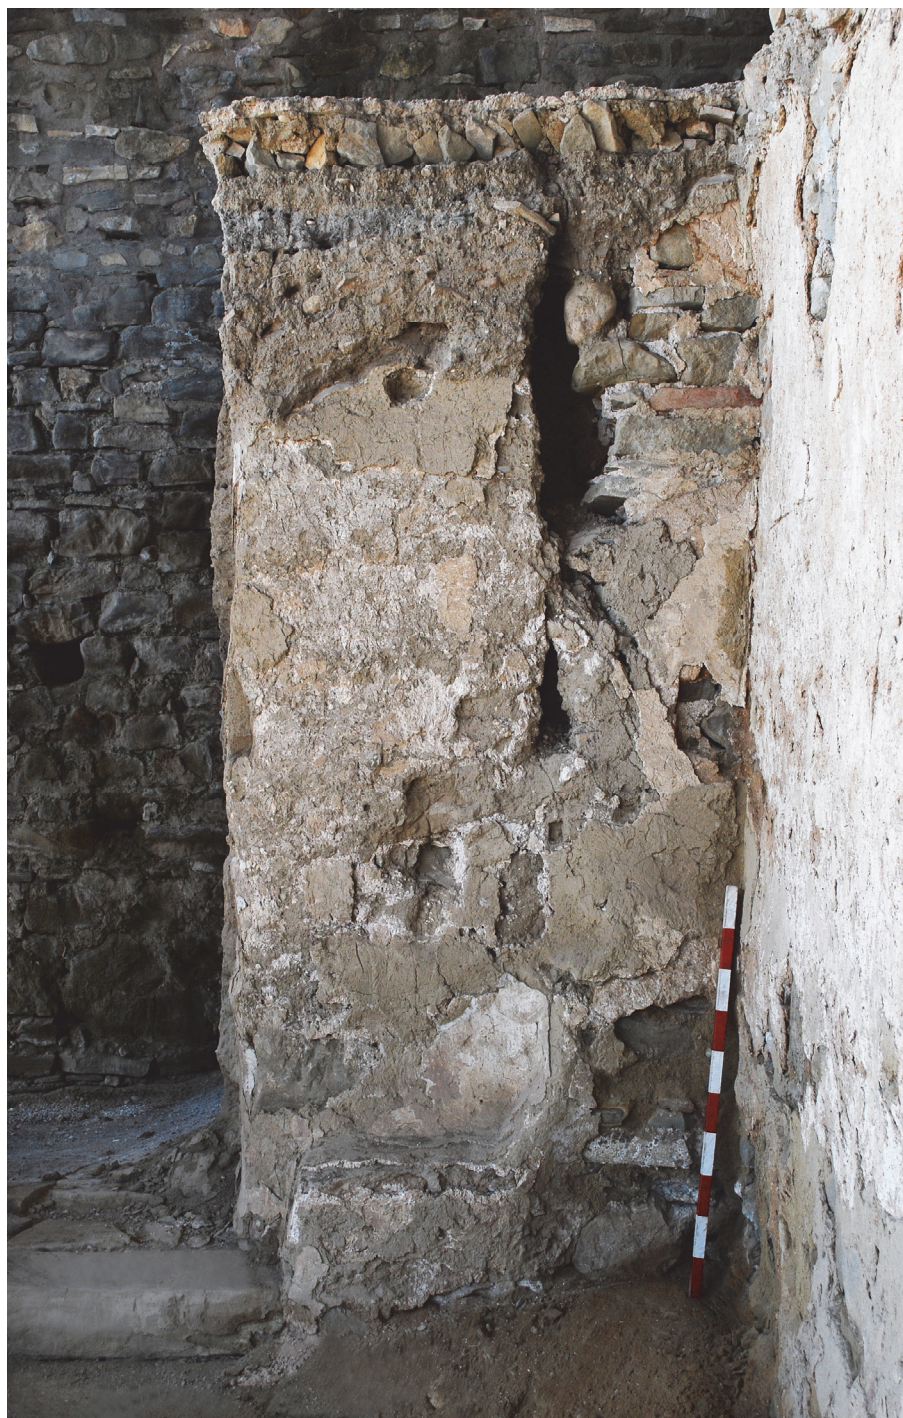
Fig. 6. Upgraded wall north of the entrance into the north aisle of the church
(photography - M. Tutkovski)

thin layer of lime plaster was used (2-3 mm) to level the clay.² The layer for painting – *intonaco* was set over it, with depth totalling 8-10 mm (Fig.3). At a later point, the entrance in the south wall was blocked up with mudbricks, while, possibly around the same time, some reconstruction work was done to the west wall of the basilica, right next to the entryway leading to the north aisle. Namely, the north portion of the stone wall had been partially demolished and rebuilt using mudbricks (Fig.6).

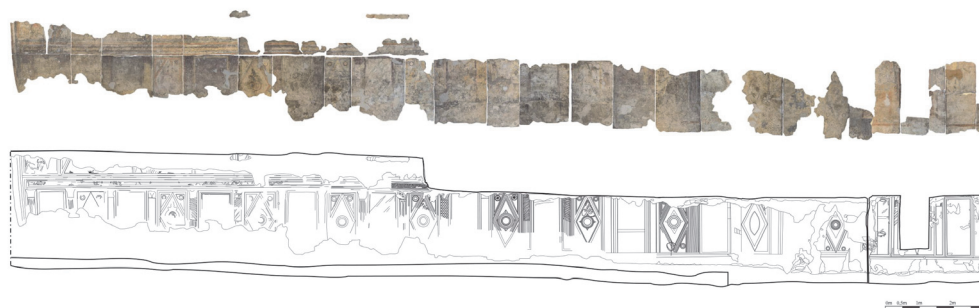
Fig. 7. Paintings on the north wall - II and III phase (drawing: T. Mitrova, photography and processing - M. Tutkovski)

The second phase painting is best preserved on the north and west walls of the church (Fig. 7-8). The face of the wall is covered with a red reinforced clay (identical to the clay used for blocked-up doorway in the south aisle), with thickness that varies between 5 - 15 mm. Over the clay a thin lime plaster layer was spread (3 - 5 mm), with another layer of grey-greenish reinforced clay 5 - 10 mm thick over it. The last layer was levelled with a thin coating of plaster (1 - 2 mm), over which the *intonaco* was set, totalling 10 mm depth (Fig. 9). At few points on the north wall there were supporting layers made without use of the reddish clay and the plaster coating over it. Instead, grey-greenish reinforced clay was used, followed by the previously described subsequent layers, in the same manner as the rest of the walls (Fig. 10).

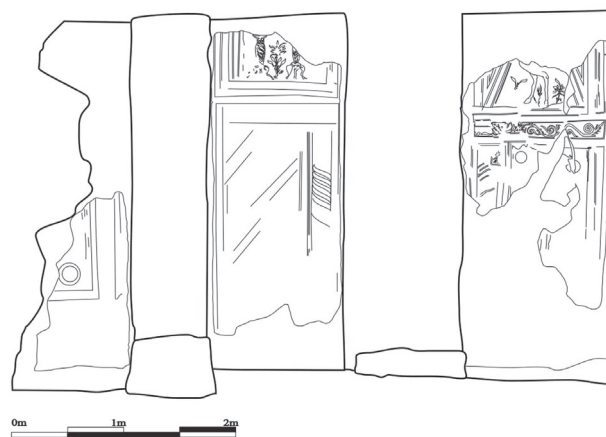
Fig. 8. Paintings on the west wall of the basilica - II phase (drawing: T. Mitrova)

The west wall has two zones of paintings preserved as well (Fig. 8), where aside from the usual depictions of pseudo-architectural plates and incrustations, the lower halves of two compositions survive in the second zone: north of the entrance

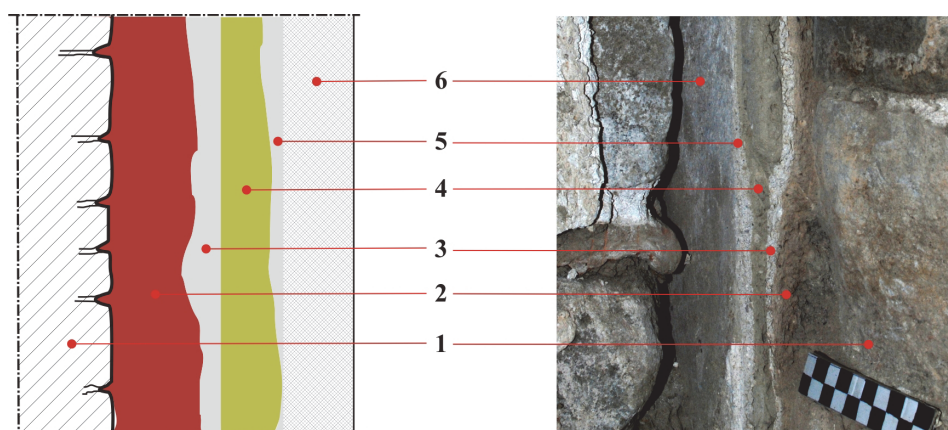
Fig. 9. West wall - cross section of the layers II painting phase. 1) Stone wall 2) Reddish clay reinforced with straw 3) Lime mortar 4) Grey-greenish clay reinforced with straw 5) Thin layer of lime mortar 6) Reinforced lime mortar - arriccio and intonaco of the II painting phase (drawing and photography - M. Tutkovski)

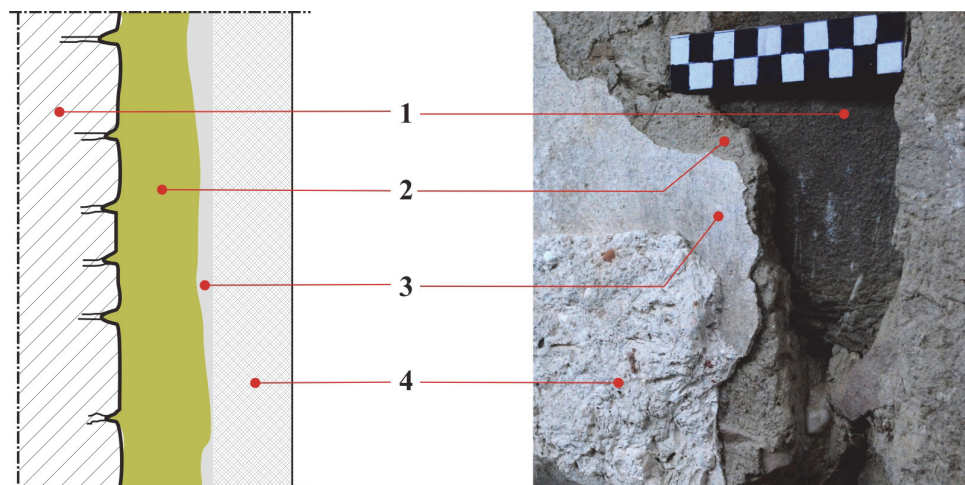
Fig. 10. North wall – cross section of the layers II painting phase. 1) Stone wall 2) Grey-greenish clay reinforced with straw 3) Thin layer of lime mortar 4) Reinforced lime mortar – arriccio and intonaco of the II painting phase (drawing and photography - M. Tutkovski)

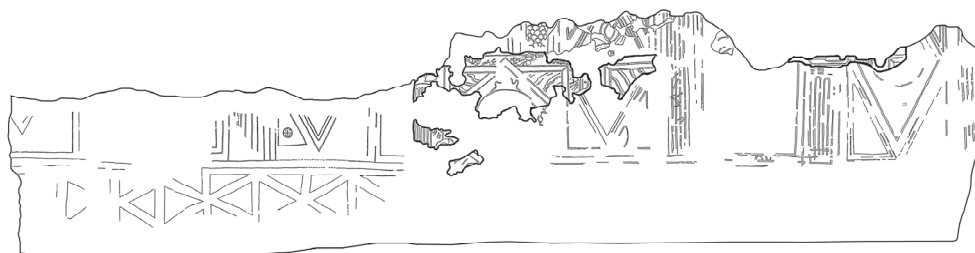
Fig. 11. South wall – paintings of the II phase with marked areas from the I phase. (drawing: M. Petrovski, B. Damjanovski, B. Kuzmanovski; processing - M. Tutkovski)

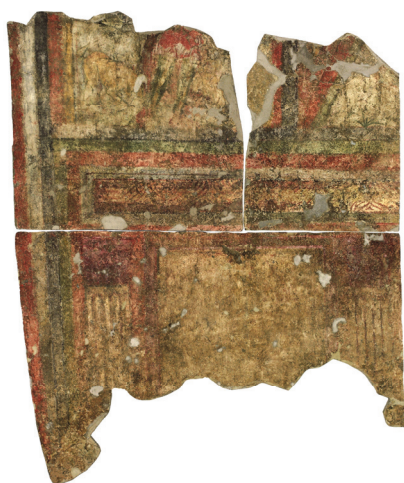
Fig. 12. Detail of the paintings of the north wall with the representation of the Prophet Daniel in the lions' den (photography and montage - M. Tutkovski)

The west side of the north wall has remains of the second painting zone; however, it survives only in fragments. On the west end of this wall the lower half of a scene is preserved, depicting the Old Testament prophet Daniel in the lion's den.⁵ The two painting zones are separated by a wide band made up of horizontal lines in varied colours, complemented by graphically formed geometrical motifs, replicated throughout the entire band length (Fig.12).

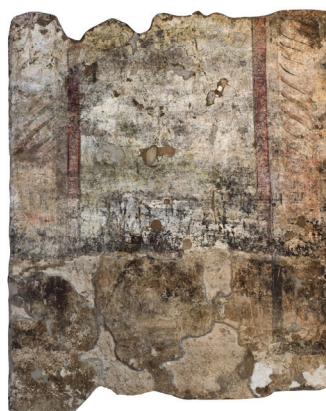
Fig. 13. North wall - later interventions on the paintings from the II phase (photography - M. Tutkovski)

Later interventions carried out over the second phase, paintings were discovered in the central part of the north wall, where the lower portions of the frescoes were painted over; first by a layer of grey-greenish clay covered directly with the base plaster for the painting, 2 – 4 mm thick. The painting technique used here was *secco* which has barely survived, yet it is visible enough to attest that the painters followed the same decorative scheme (Fig.13).⁶

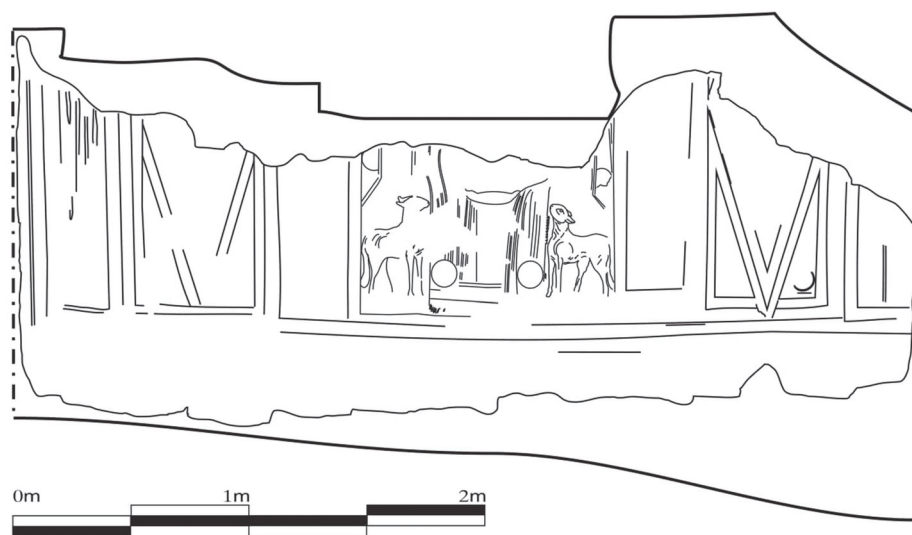
Fig. 14. Paintings on the east wall of the north aisle – III phase. (drawing: T. Mitrova)

The walls in this phase were built of roughly shaped stones bound by lime mortar, and the same mortar was used to coat the interior face of the walls. The painting is preserved only in the first zone; the consistent motif of pseudo-marble plates between pilasters continues on the north wall (Fig.7), while in the central part of the east wall beneath the window, a symbolic scene is located depicting two lambs surrounding a spring of water.⁷ The portrayed lambs are flanked on both sides by painted imitation of marble plates and pilasters (Fig.14-15).

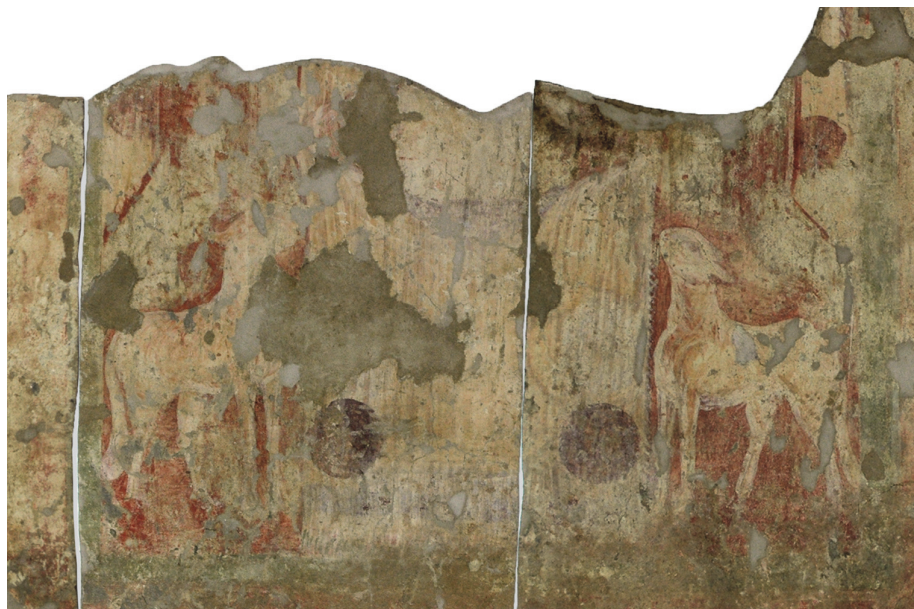
Fig. 15. Detail of the paintings of the east wall. Representation of lambs around the font (photography - M. Tutkovski)

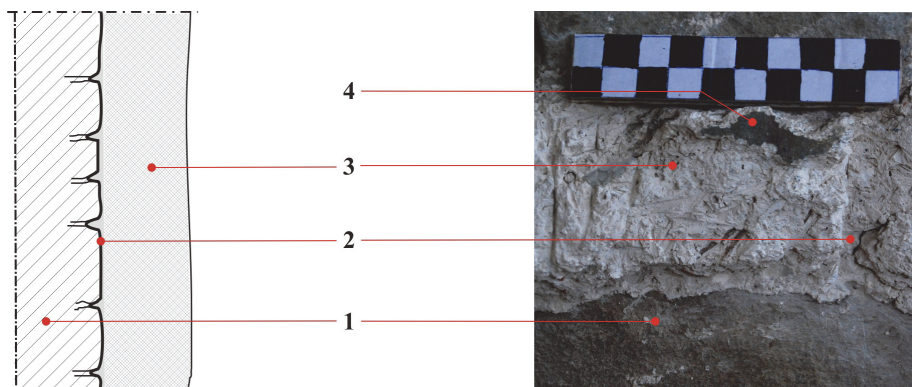
Fig. 16. East wall – cross section of the layers from the III painting phase. 1) Stone wall 2) Thin layer of lime mortar 3) Reinforced lime mortar – arriccio and intonaco (drawing and photography - M. Tutkovski)

The painting technique and technology used in this phase differs from those previously used in the church. Namely, the painting foundation consists of a single layer of reinforced lime plaster, 10 – 14 mm thick. Its surface was levelled out and finely smoothed to create the appropriate final layer - intonaco, where the painting would have been executed (Fig.16). Painting was done using the fresco technique,

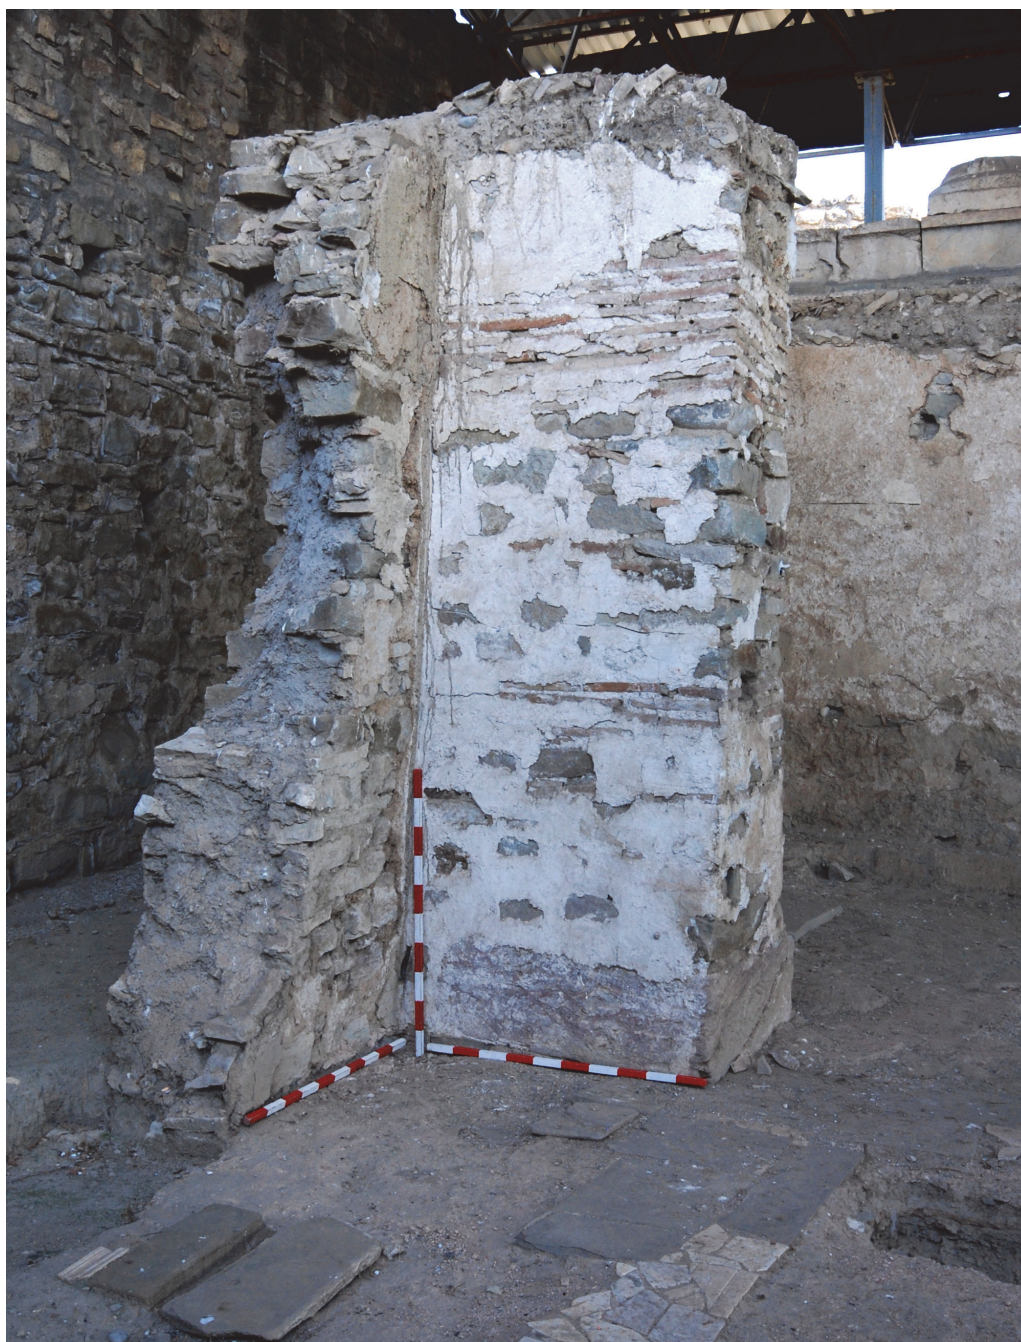
Fig.17. West pilaster of the north aisle (photography - M. Tutkovski)

with the exception of few additional painting interventions, such as the medallions with the monogram of Christ, painted in secco. It is likely that during this building phase a bench was built next to the north wall of the church, and it covered the lower portions of the second phase painting (Fig.17).⁸

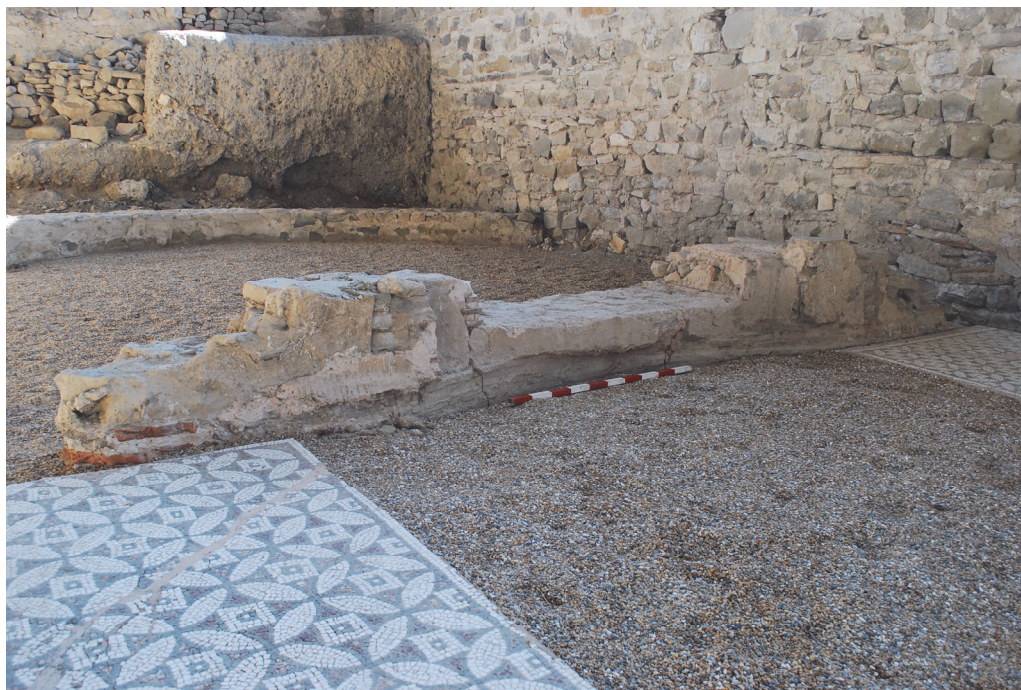
Fig. 18. Altar screen placed on the top of the apse of the first building phase (photography - M. Tutkovski)

Around the same time, a new altar screen was remodelled and founded over the apse foundations belonging to the first building stage of the church (Fig.1.18). Unconventionally, the altar screen was not made of marble columns and screens; it was constructed using stones and bricks bound with lime mortar instead. Only two fragments of fresco-paintings from the altar screen have survived, flanking the central entrance to the altar. The decoration is composed of simple floral motifs (Fig.19).

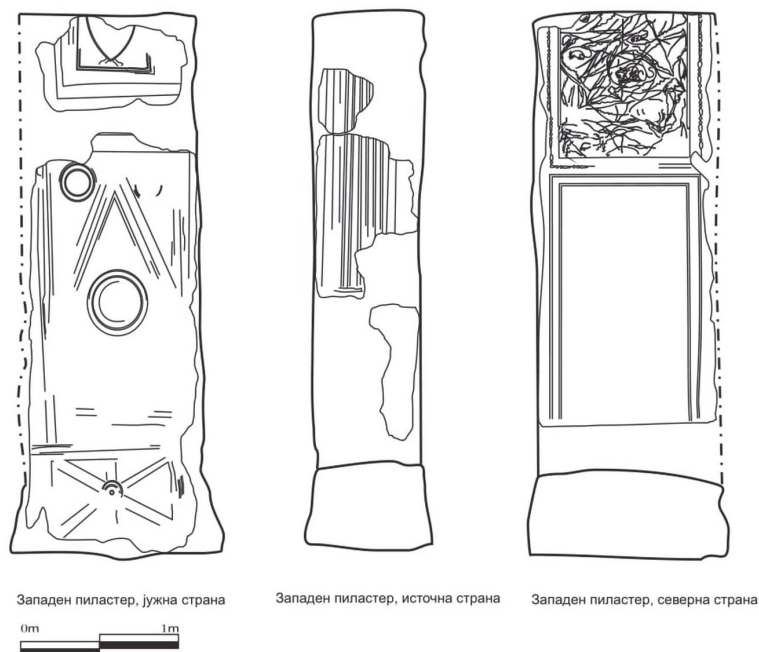
Fig. 20. Paintings on the west pilaster – IV phase (drawing: T. Mitrova).

The west pilaster was decorated on all of its sides (Fig. 20), with painting applied in two zones; except on its east side where a fluted column was painted over the entire height of the pilaster. The south facing side of the pilaster has painted remains at the socle, an eight-pointed cross inscribed in a rectangular frame (identical to the socle decorations of the second phase), and above it, pseudo-marble plates painted in the first and second zones. The north facing side of the pilaster was decorated with a painted marble plate in the first zone, while the second zone contains a unique depiction of a ferocious rat with two small mice, painted against an abstract background (Fig. 21).¹²

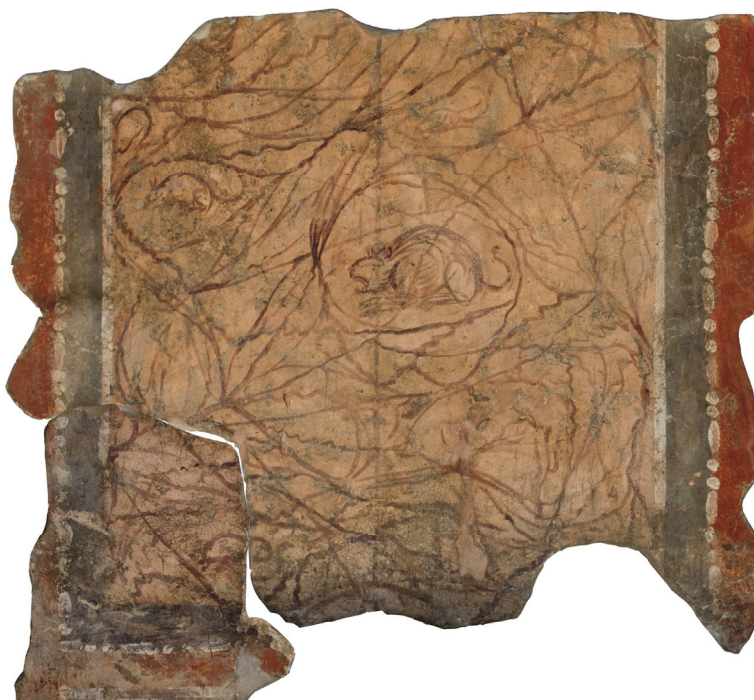
Fig. 21. Detail of the paintings on the north side of the west pilaster with representations of rat and mice (photography - M. Tutkovski)

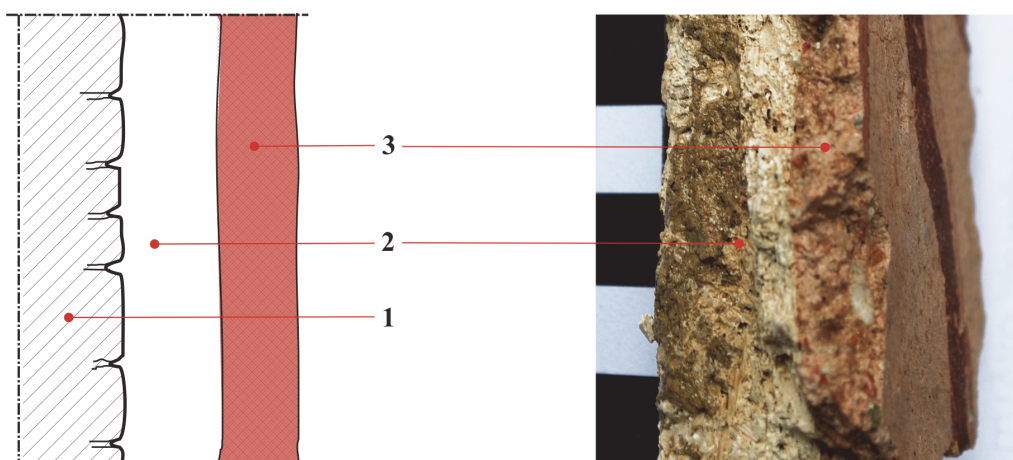
Fig. 22. West pilaster, north side - cross section of the layers from the IV painting phase
 1) Stone wall 2) Reinforced lime mortar 3) Hydraulic mortar - arriccio and intonaco
 (drawing and photography - M. Tutkovski)

applied (10 mm thick) over all sides of the pilaster, and the layer of plaster was spread over it, consisting of reinforced lime mortar with thickness of 10 – 14 mm. Plastering the north side of the pilaster was done in an unusual manner, a foundation layer consisting of reinforced lime mortar was first applied and a layer of hydraulic plaster with a small percentage of crushed brick was spread over it. The intonaco layer was formed by simply flattening out the last layer of hydraulic plaster (Fig. 22).

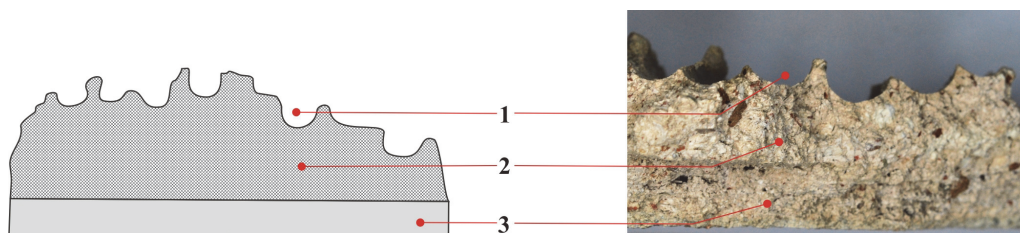
Fig. 23. Cross section of the layers from the ceiling paintings 1) Imprints of reed 2) Lime mortar with additions of crushed brick and straw 3) Arriccio and intonaco (drawing and photography - M. Tutkovski)

During the archaeological excavations many fresco fragments from the ceilings were found in the destruction layers covering the floors of the north and south aisles of the Old Episcopal basilica.¹³ The ceilings were built using wooden beams and reeds with an east-west orientation.¹⁴ Reeds were covered with a layer of reinforced lime plaster containing crushed brick and straw (40 – 50 mm), while the painting plaster measuring 5 – 10 mm thickness was applied over it (Fig. 23). According to the investigations on the fragments coming from the ceiling, the evidence points to a single phase of painting, executed in a combination of both fresco and secco techniques.¹⁵

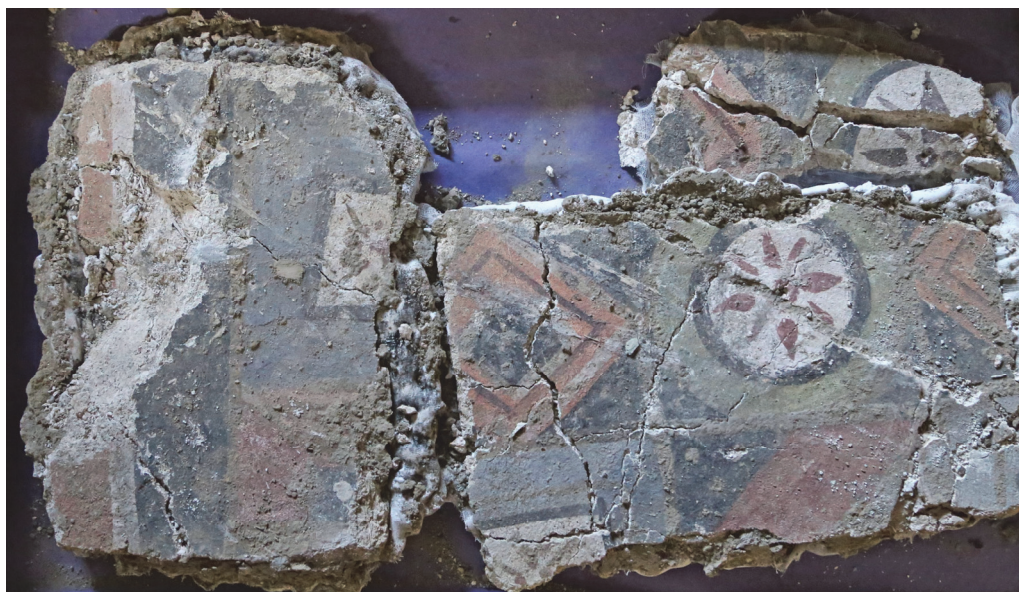
Fig. 24. North aisle - ceiling paintings (photography - K. Frangova)

The decorative arrangement on the church ceiling is composed of a wide border filled with stylized floral motifs. The decorative border follows the length of the side aisles and covers the central area of the ceiling, designed as a network of square fields filled with concentric rhombuses and squares, eight-pointed stars and cubes in pseudo-three-dimensional perspective (Fig. 24).¹⁶
